# Access Compliance Report Public Rights-of-Way (Curb Ramps)

Main Street: FENWICK\_PL Cross Street: CAMBERA\_LN Location: E

ADA ID: RPRK211013133015 Ramp Type: Type 1 - Perpendicular Diagonal Initial Pass/Fail: Pass Overall Compliance: No Severity Score: 10

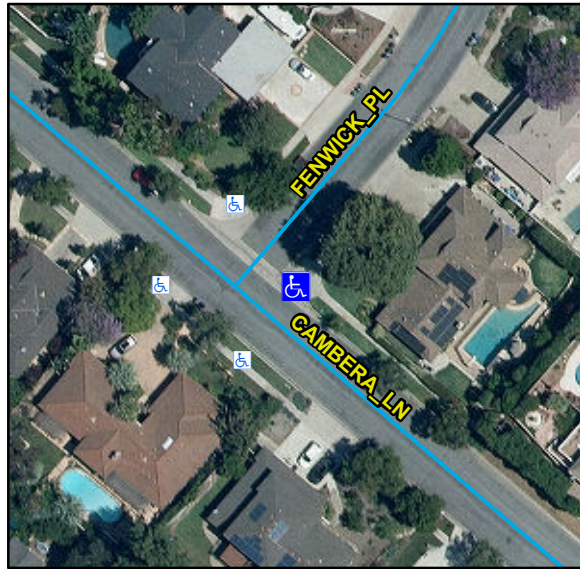
| Compliance | Description | Data | Compliance | Description | Data |
|---|---|---|---|---|---|
| No | Landing Cross Slope (%) | 2.6 | No | DWS Provided | No |

Remove & Replace Curb Ramp With Two New Directional Ramps or Equivalent.

R304.2.1, R304.5.3, R305, STD 1115
