# Access Compliance Report Public Rights-of-Way (Curb Ramps)

Main Street: LA\_LIMONAR\_DR Cross Street: BIMINI\_DR Location: N

ADA ID: RPRK211013133816 Ramp Type: Type 1 - Perpendicular Diagonal Initial Pass/Fail: Pass Overall Compliance: No Severity Score: 20

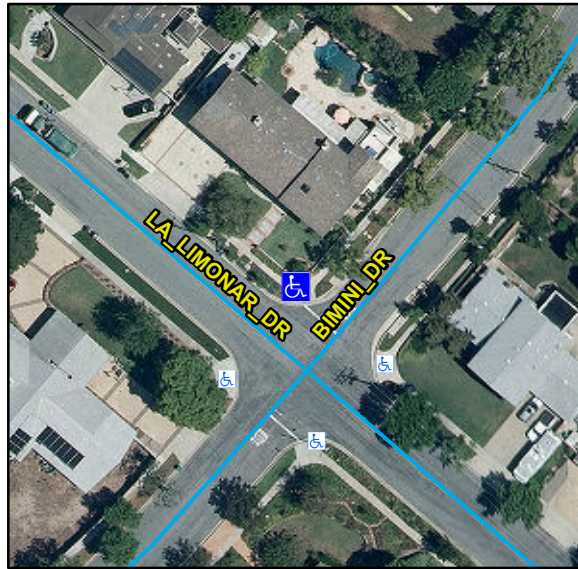
| Compliance | Description | Data | Compliance | Description | Data |
|---|---|---|---|---|---|
| No | Landing Width (in) | N/A | N/A | Flare Slope RT (%) | 4.1 |
| No | Landing Run Slope (%) | N/A | N/A | Flare Traversable RT | No |
| No | Landing Cross Slope (%) | N/A | No | DWS Provided | No |
| No | Gutter Cross Slope (%) | 3.2 | | | |

Remove & Replace Curb Ramp With Two New Directional Ramps or Equivalent. Remove & Replace Gutter.
