# Access Compliance Report Public Rights-of-Way (Curb Ramps)

Main Street: BIMINI\_DR Cross Street: LA LIMONAR\_DR Location: W

ADA ID: RPRK211013134047 Ramp Type: Type 4 - Parallel Initial Pass/Fail: Fail Overall Compliance: No Severity Score: 2

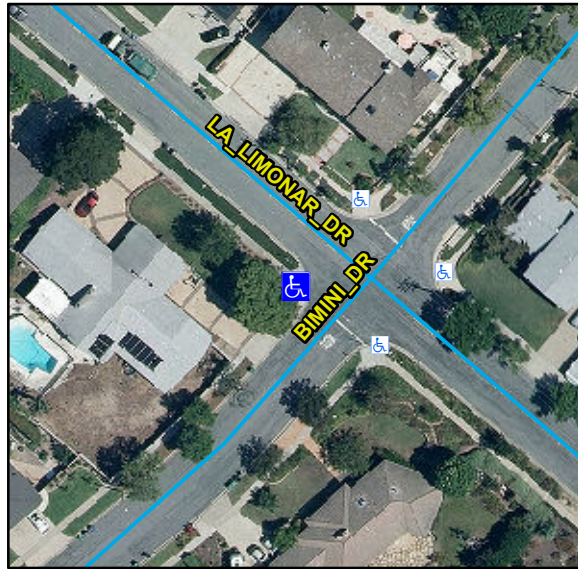
| Compliance | Description | Data | Compliance | Description | Data |
|---|---|---|---|---|---|
| No | Ramp Cross Slope LT (%) | 4.5 | No | Ramp Cross Slope RT (%) | 3.6 |

**Remove & Replace Curb Ramp With Two New Directional Ramps or Equivalent.**

**R204.3, R304.5.3, STD 1115**
