# Access Compliance Report Public Rights-of-Way (Curb Ramps)

Main Street: BRUNSWICK\_WAY Cross Street: LA\_LIMONAR\_DR Location: E

ADA ID: RPRK211013135012 Ramp Type: Type 4 - Parallel Initial Pass/Fail: Fail Overall Compliance: No Severity Score: 30

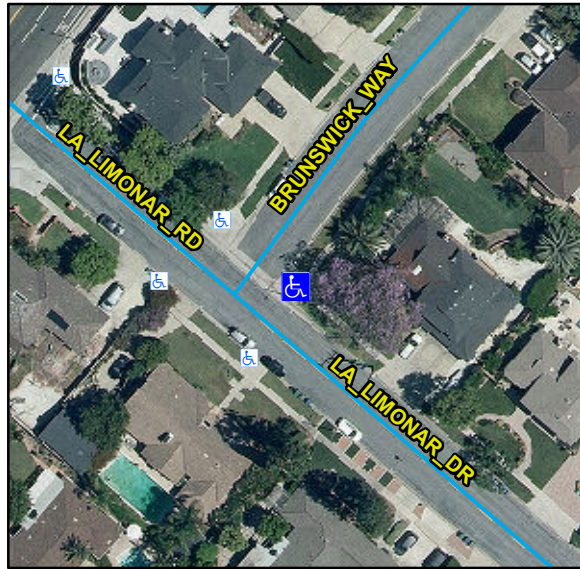
| Compliance | Description | Data | Compliance | Description | Data |
|---|---|---|---|---|---|
| No | Ramp Cross Slope LT (%) | 4.6 | No | Ramp Cross Slope RT (%) | 7.1 |

**Remove & Replace Curb Ramp With Two New Directional Ramps or Equivalent.**

**R304.5.3, STD 1115**
