# Access Compliance Report Public Rights-of-Way (Curb Ramps)

| Main Street: LA_LIMONAR_RD | | Cross Street: BRUNSWICK_WAY | | Location: | N |
| ADA ID: RPRK211013135218 | Ramp Type: Type 4 - Parallel | Initial Pass/Fail: Fail | Overall Compliance: No | Severity Score: | 2 |

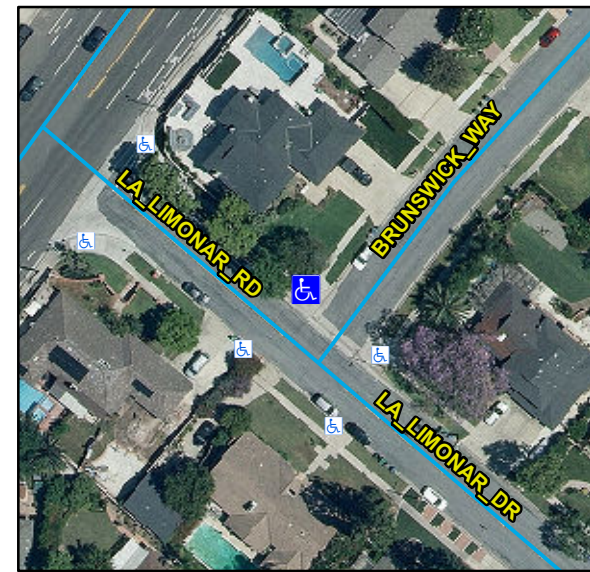
| Compliance | Description | Data | Compliance | Description | Data |
|---|---|---|---|---|---|
| No | Ramp Cross Slope LT (%) | 3.7 | No | Ramp Cross Slope RT (%) | 4.8 |

**Remove & Replace Curb Ramp With Two New Directional Ramps or Equivalent.**

**R304.5.3, STD 1115**

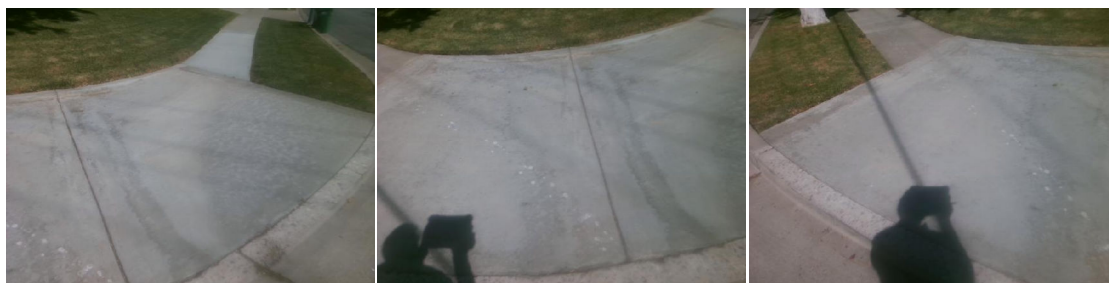
| Compliance | Description | Data | Compliance | Description | Data |
|---|---|---|---|---|---|
| N/A | Ramp Length LT (in) | 113 | N/A | Ramp Length RT (in) | 131 |
| Yes | Ramp Width LT (in) | 121 | Yes | Ramp Width RT (in) | 122 |
| Yes | Ramp Run Slope LT (%) | 1.1 | Yes | Ramp Run Slope RT (%) | 3.1 |
