# Access Compliance Report Public Rights-of-Way (Curb Ramps)

Main Street: NEWPORT\_AVE Cross Street: LA\_LIMONAR\_RD Location: SE

ADA ID: RPRK211013135509 Ramp Type: Type 1 - Perpendicular Diagonal Initial Pass/Fail: Pass Overall Compliance: No Severity Score: 10

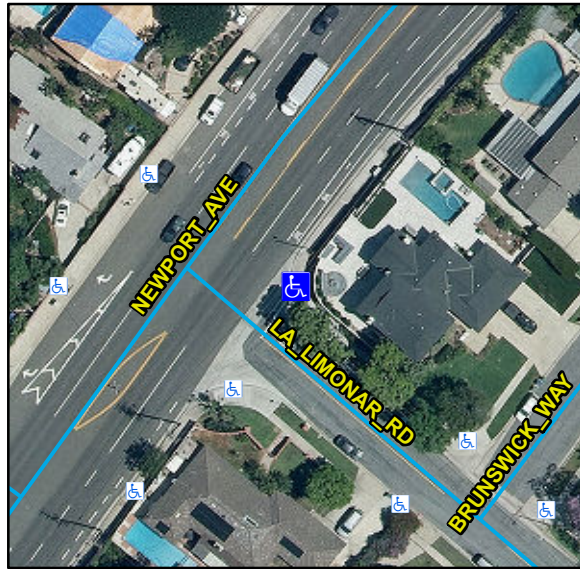
R304.2.2, R304.2.1, R304.2.2-Perp, R304.3.2-Para, R304.5.3, STD 1115

| Compliance | Description | Data | Compliance | Description | Data |
|---|---|---|---|---|---|
| No | Landing Width (in) | N/A | N/A | Flare Slope RT (%) | 4.4 |
| No | Landing Run Slope (%) | N/A | N/A | Flare Traversable RT | No |
| No | Landing Cross Slope (%) | N/A | Yes | DWS Provided | Yes |
| N/A | Landing Movement Obstructed? | Yes | Yes | DWS Contrast | Yes |
| | Landing Movement Type | Curb | Yes | DWS Length (in) | 36 |

Remove & Replace Curb Ramp With Two New Directional Ramps or Equivalent.
