# Access Compliance Report Public Rights-of-Way (Curb Ramps)

Main Street: NEWPORT\_AVE Cross Street: LEMON\_HILL\_DR Location: W

ADA ID: RPRK211013142436 Ramp Type: Type 1 - Perpendicular Diagonal Initial Pass/Fail: Fail Overall Compliance: No Severity Score: 2

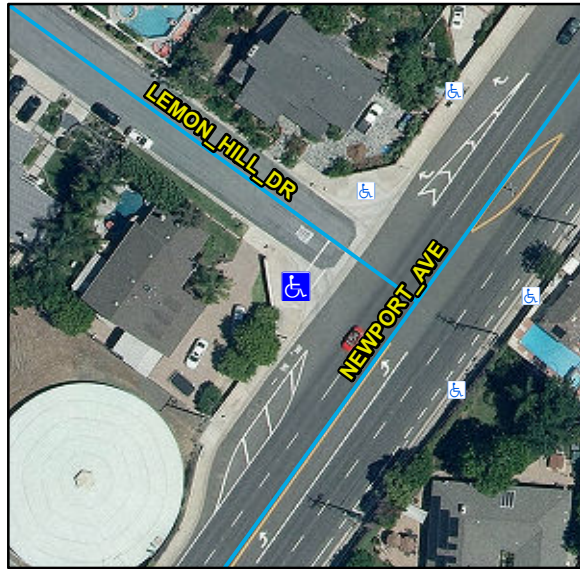
| Compliance | Description | Data | Compliance | Description | Data |
|---|---|---|---|---|---|
| No | Ramp Cross Slope (%) | 4.8 | N/A | Flare Traversable LT | N/A |
| N/A | Gutter Ponding | N/A | No | Curb Slope | 7.2 |

Remove & Replace Curb Ramp With Two New Directional Ramps or Equivalent.

R304.2.2, R204.3, R304.5.3, STD 1115
