# Access Compliance Report Public Rights-of-Way (Curb Ramps)

Main Street: LEMON\_HILL\_DR Cross Street: NEWPORT\_AVE Location: N

ADA ID: RPRK211013142632 Ramp Type: Type 1 - Perpendicular Diagonal Initial Pass/Fail: Pass Overall Compliance: No Severity Score: 4

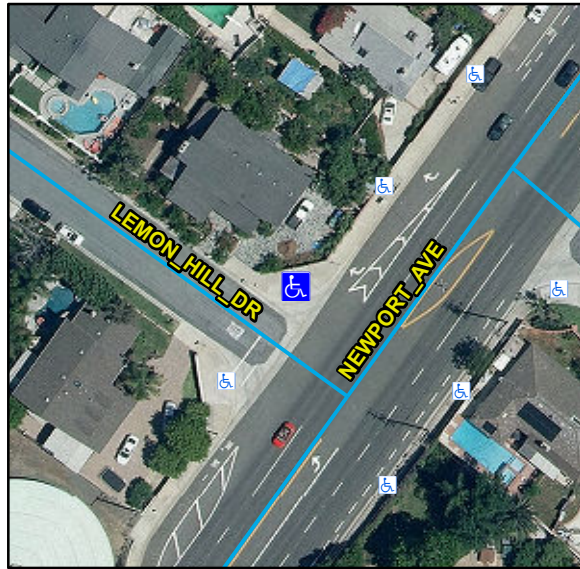
| Compliance | Description | Data | Compliance | Description | Data |
|---|---|---|---|---|---|
| No | Landing Cross Slope (%) | 2.7 | Yes | DWS Provided | Yes |
| Yes | Gutter Ponding | No | No | Curb Slope | 6 |

Remove & Replace Curb Ramp With Two New Directional Ramps or Equivalent.

R304.2.2, R304.2.1, R304.5.3, STD 1115
