# Access Compliance Report Public Rights-of-Way (Curb Ramps)

Main Street: ST\_JOHN\_PL Cross Street: BIMINI\_DR Location: NE

ADA ID: RPRK211013143555 Ramp Type: Type 1 - Perpendicular Diagonal Initial Pass/Fail: Fail Overall Compliance: No Severity Score: 2

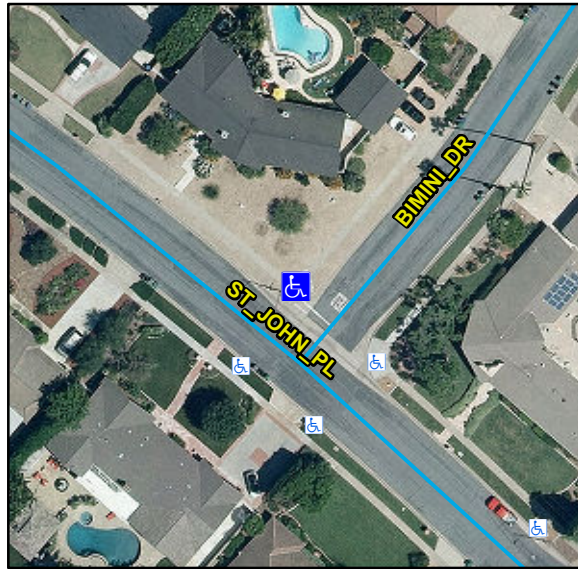
| Compliance | Description | Data | Compliance | Description | Data |
|---|---|---|---|---|---|
| No | Ramp Cross Slope (%) | 3.4 | N/A | Flare Traversable LT | N/A |

Remove & Replace Curb Ramp With Two New Directional Ramps or Equivalent.

R304.5.3, STD 1115
