# Access Compliance Report Public Rights-of-Way (Curb Ramps)

Main Street: BIMINI\_DR Cross Street: ST\_JOHN\_PL Location: SE

ADA ID: RPRK211013143924 Ramp Type: Type 1 - Perpendicular Diagonal Initial Pass/Fail: Pass Overall Compliance: No Severity Score: 20

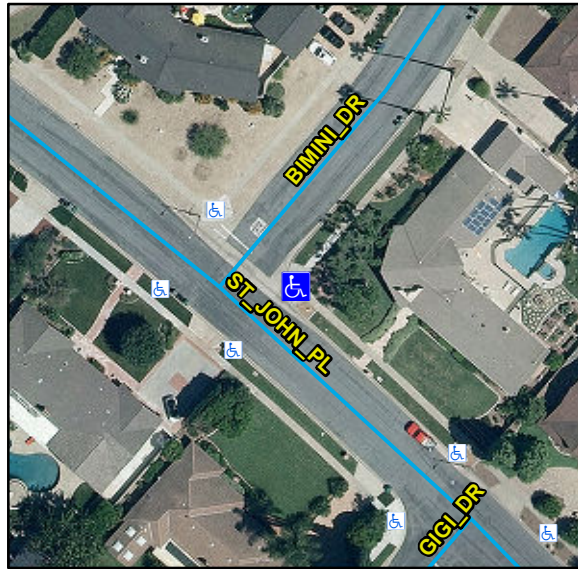
| Compliance | Description | Data | Compliance | Description | Data |
|---|---|---|---|---|---|
| No | Landing Cross Slope (%) | N/A | No | DWS Provided | No |

Remove & Replace Curb Ramp With Two New Directional Ramps or Equivalent.
