# Access Compliance Report Public Rights-of-Way (Curb Ramps)

| Main Street: ST_VINCENT_PL | | Cross Street: BIMINI_DR | | Location: | S |
| ADA ID: RPRK211013144310 | Ramp Type: Type 6 - Directional 1 | Initial Pass/Fail: Pass | Overall Compliance: No | Severity Score: | 14 |

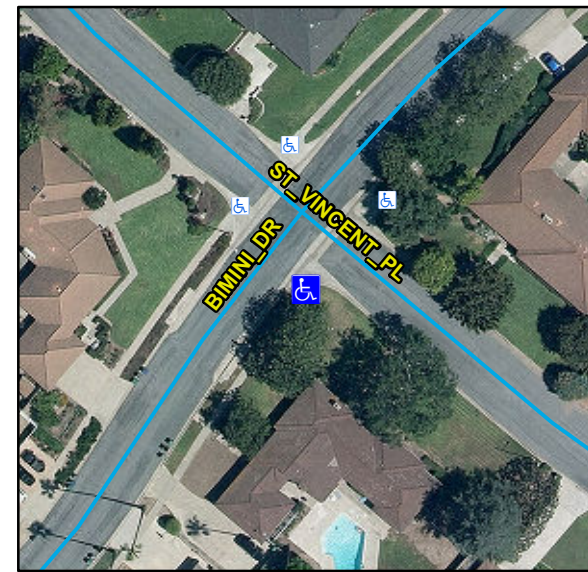
| Compliance | Description | Data | Compliance | Description | Data |
|---|---|---|---|---|---|
| | Addl Para Ramp Right? | No | No | DWS Provided | No |
| No | Landing Length (in) | 45 | N/A | DWS Length (in) | N/A |

Remove & Replace Entire Ramp.

R304.2.1, R305, STD 1115

Total Cost: \$ 3080

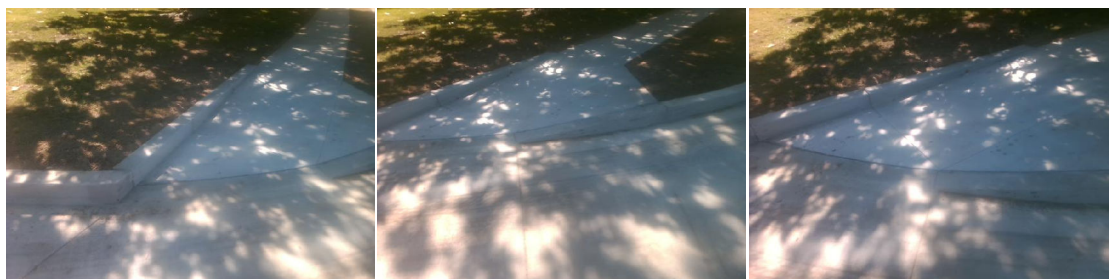
| Compliance | Description | Data | Compliance | Description | Data |
|---|---|---|---|---|---|
| N/A | Ramp Length (in) | 126 | Yes | Flare Type LT | Curbed2 |
| Yes | Ramp Width (in) | 85 | | | |
| Yes | Ramp Run Slope (%) | 2.1 | N/A | Flare Slope LT (%) | N/A |
| Yes | Ramp Cross Slope (%) | 0.1 | N/A | Flare Traversable LT | N/A |
| Yes | Grade Break | Yes | N/A | Flare Type RT | |
