# Access Compliance Report Public Rights-of-Way (Curb Ramps)

| Main Street: ST_VINCENT_PL | | Cross Street: BIMINI_DR | | Location: | E |
| ADA ID: RPRK211013144646 | Ramp Type: Type 6 - Directional 1 | Initial Pass/Fail: Pass | Overall Compliance: No | Severity Score: | 10 |

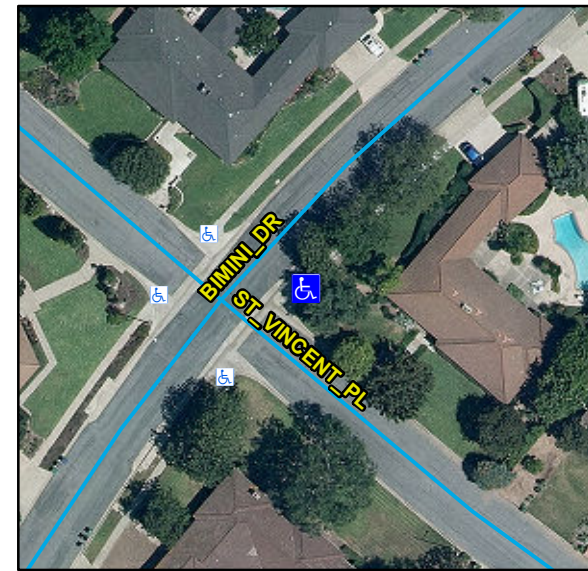
| Compliance | Description | Data | Compliance | Description | Data |
|---|---|---|---|---|---|
| | Addl Para Ramp Right? | No | No | DWS Provided | No |

Possible Solutions:

Install Detectable Warning System.
