# Access Compliance Report Public Rights-of-Way (Curb Ramps)

Main Street: ST\_VINCENT\_PL Cross Street: BIMINI\_DR Location: N

ADA ID: RPRK211013145003 Ramp Type: Type 6 - Directional 1 Initial Pass/Fail: Pass Overall Compliance: No Severity Score: 10

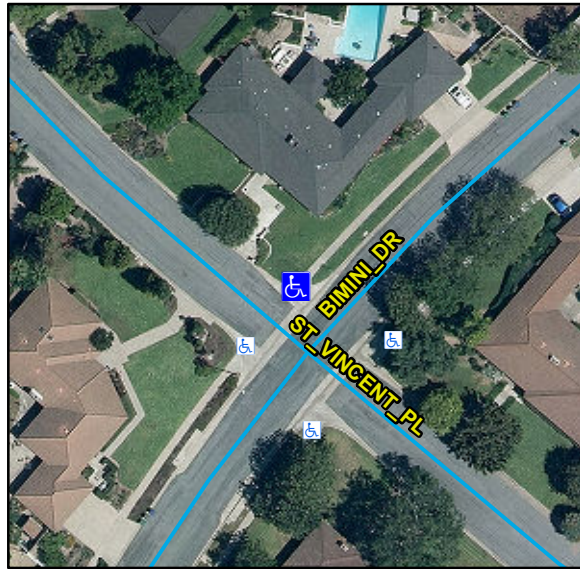
| Compliance | Description | Data | Compliance | Description | Data |
|---|---|---|---|---|---|
| | Addl Para Ramp Right? | No | No | DWS Provided | No |

Install Detectable Warning System.

R305, STD 1115

Total Cost: \$ 600
