# Access Compliance Report Public Rights-of-Way (Curb Ramps)

Main Street: ST\_VINCENT\_PL Cross Street: BIMINI\_DR Location: W

ADA ID: RPRK211013145234 Ramp Type: Type 6 - Directional 1 Initial Pass/Fail: Pass Overall Compliance: No Severity Score: 10

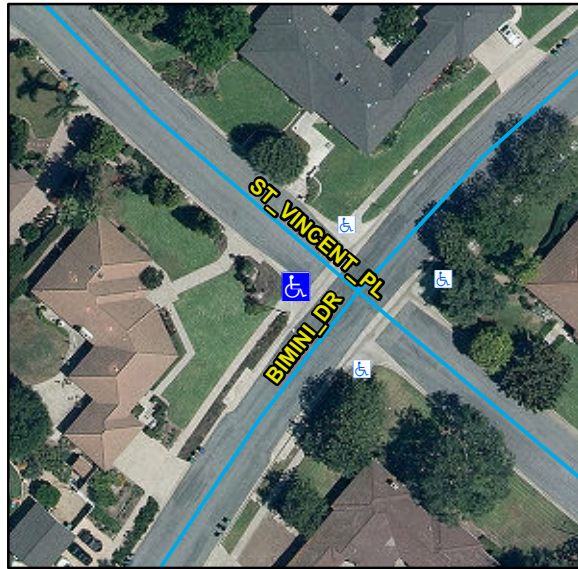
| Compliance | Description | Data | Compliance | Description | Data |
|---|---|---|---|---|---|
| No | Landing Run Slope (%) | 2.2 | | DWS Offset Type | N/A |

**Remove & Replace Entire Ramp.**

**R304.2.2-Perp, R304.3.2-Para, R305, STD 1115**
