Main Street: GIGI\_DR Cross Street: ST\_JOHN\_PL Location: W

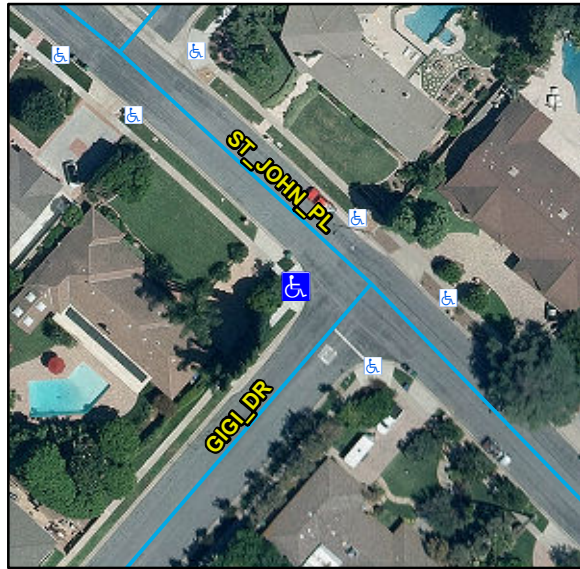
ADA ID: RPRK211013150057 Ramp Type: Type 1 - Perpendicular Diagonal Initial Pass/Fail: Pass Overall Compliance: No Severity Score: 11

| Compliance | Description | Data | Compliance | Description | Data |
|---|---|---|---|---|---|
| No | Landing Cross Slope (%) | 5.4 | Yes | DWS Provided | Yes |
| No | Gutter Cross Slope (%) | 3.7 | | | |

Remove & Replace Curb Ramp With Two New Directional Ramps or Equivalent. Remove & Replace Gutter.
