# Access Compliance Report Public Rights-of-Way (Curb Ramps)

Main Street: ST\_JOHN\_PL Cross Street: GIGI\_DR Location: SW

ADA ID: RPRK211013150351 Ramp Type: Type 4 - Parallel Initial Pass/Fail: Fail Overall Compliance: No Severity Score: 30

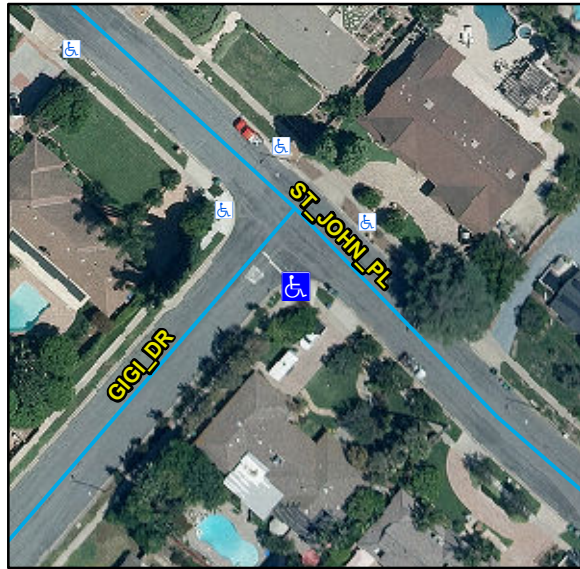
| Compliance | Description | Data | Compliance | Description | Data |
|---|---|---|---|---|---|
| No | Ramp Cross Slope LT (%) | 4 | No | Ramp Cross Slope RT (%) | 7.9 |

**Remove & Replace Curb Ramp With Two New Directional Ramps or Equivalent.**

**R304.5.3, STD 1115**
