# Access Compliance Report Public Rights-of-Way (Curb Ramps)

Main Street: GIGI\_DR Cross Street: SMOKE\_TREE\_LN Location: SE

ADA ID: RPRK211013150810 Ramp Type: Type 1 - Perpendicular Diagonal Initial Pass/Fail: Pass Overall Compliance: No Severity Score: 20

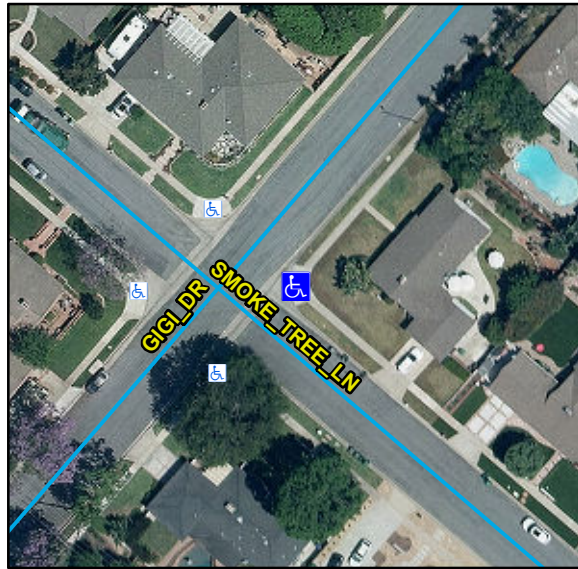
## Field Measurements/Component Compliance

| Compliance | Description | Data | Compliance | Description | Data |
|---|---|---|---|---|---|
| No | Landing Width (in) | N/A | N/A | Flare Slope RT (%) | 3.3 |
| No | Landing Run Slope (%) | N/A | N/A | Flare Traversable RT | No |
| No | Landing Cross Slope (%) | N/A | No | DWS Provided | No |

**Remove & Replace Curb Ramp With Two New Directional Ramps or Equivalent.**
