# Access Compliance Report Public Rights-of-Way (Curb Ramps)

Main Street: SMOKE\_TREE\_LN Cross Street: GIGI\_DR Location: N

ADA ID: RPRK211013151117 Ramp Type: Type 1 - Perpendicular Diagonal Initial Pass/Fail: Pass Overall Compliance: No Severity Score: 22

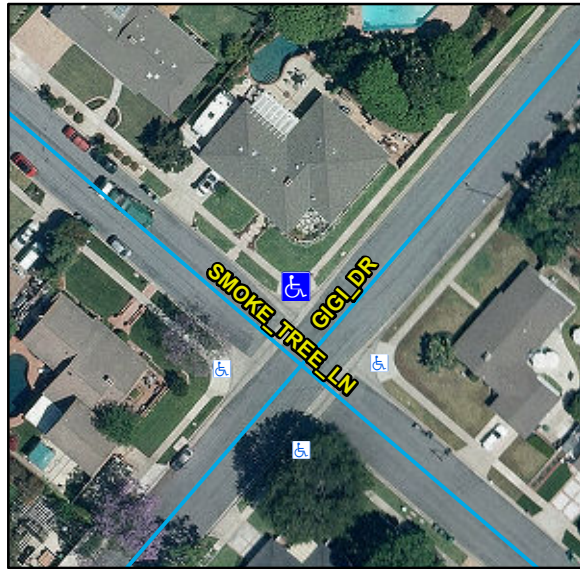
| Compliance | Description | Data | Compliance | Description | Data |
|---|---|---|---|---|---|
| No | Landing Width (in) | N/A | N/A | Flare Slope RT (%) | 3 |
| No | Landing Run Slope (%) | N/A | N/A | Flare Traversable RT | No |
| No | Landing Cross Slope (%) | N/A | No | DWS Provided | No |

Remove & Replace Curb Ramp With Two New Directional Ramps or Equivalent.

Total Cost: \$ 6160
