# Access Compliance Report Public Rights-of-Way (Curb Ramps)

Main Street: SMOKE\_TREE\_LN Cross Street: GIGI\_DR Location: SW

ADA ID: RPRK211013151424 Ramp Type: Type 1 - Perpendicular Diagonal Initial Pass/Fail: Pass Overall Compliance: No Severity Score: 22

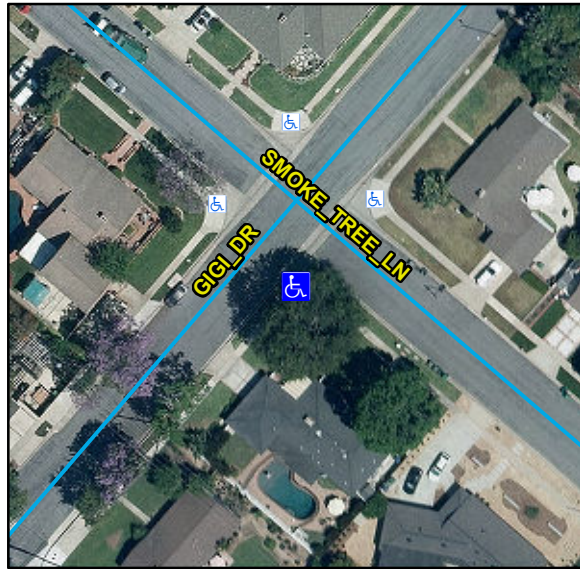
| Compliance | Description | Data | Compliance | Description | Data |
|---|---|---|---|---|---|
| No | Landing Width (in) | N/A | N/A | Flare Slope RT (%) | 4.2 |
| No | Landing Run Slope (%) | N/A | N/A | Flare Traversable RT | No |
| No | Landing Cross Slope (%) | N/A | No | DWS Provided | No |
| N/A | Landing Movement Obstructed? | Yes | N/A | DWS Contrast | N/A |
| | Landing Movement Type | Curb | N/A | DWS Length (in) | N/A |

Remove & Replace Curb Ramp With Two New Directional Ramps or Equivalent.
