# Access Compliance Report

## Public Rights-of-Way

### (Curb Ramps)

Main Street: Foothill\_BlvD Cross Street: GIGI\_DR Location: N

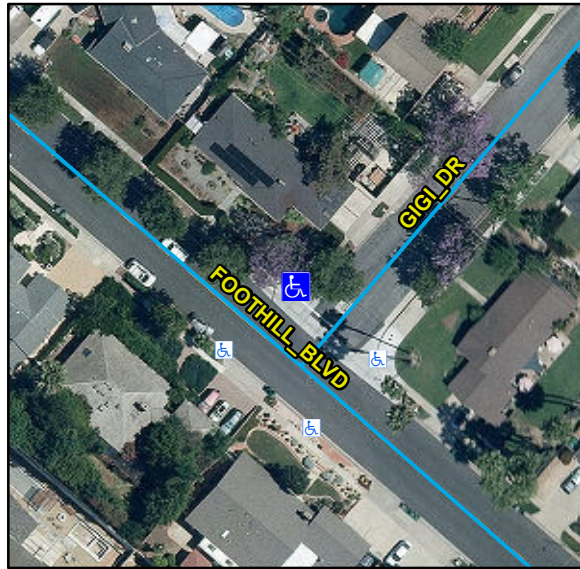
ADA ID: RPRK211013152050 Ramp Type: Type 1 - Perpendicular Diagonal Initial Pass/Fail: Pass Overall Compliance: No Severity Score: 0

| Compliance | Description | Data | Compliance | Description | Data |
|---|---|---|---|---|---|
| Yes | Gutter Ponding | No | No | Curb Slope | 6.5 |

Possible Solutions:

Remove & Replace Curb Slope.

R304.2.2, STD 1115
