# Access Compliance Report Public Rights-of-Way (Curb Ramps)

| Main Street: ORANGE_KNOLL_DR | | Cross Street: GATEWAY_DR | | Location: | E |
| ADA ID: RPRK211013171257 | Ramp Type: Type 4 - Parallel | Initial Pass/Fail: Pass | Overall Compliance: No | Severity Score: | 2 |

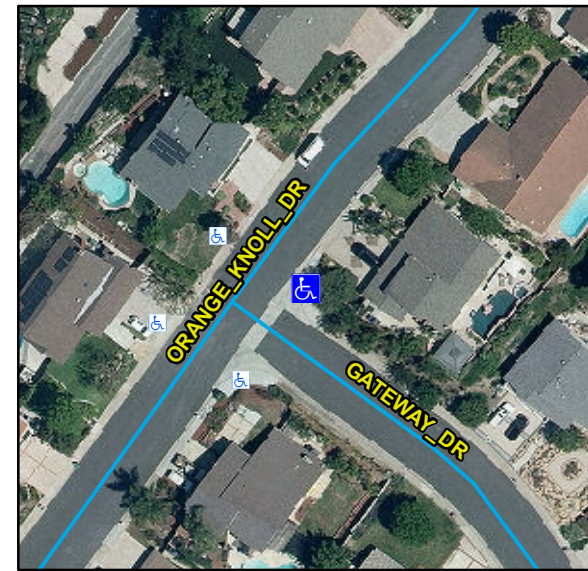
| Compliance | Description | Data | Compliance | Description | Data |
|---|---|---|---|---|---|
| No | Ramp Cross Slope LT (%) | 2.4 | Yes | Ramp Cross Slope RT (%) | 1.7 |
| No | Landing Run Slope (%) | 2.4 | Yes | DWS Full Width | Yes |

**Remove & Replace Curb Ramp With Two New Directional Ramps or Equivalent.**

**R304.5.3, R304.2.2-Perp, R304.3.2-Para, STD 1115**

Total Cost: \$ 4000

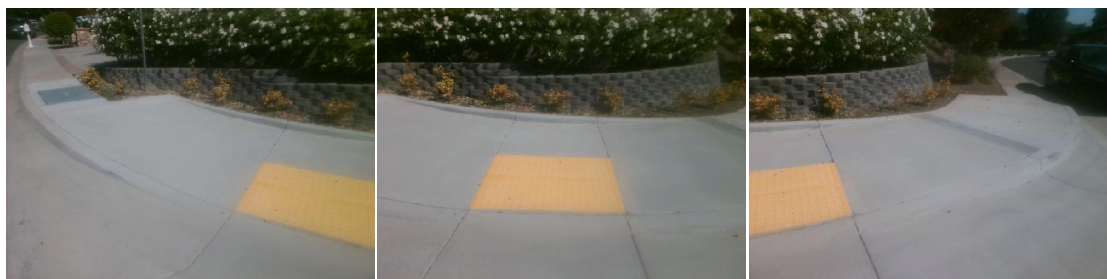
| Compliance | Description | Data | Compliance | Description | Data |
|---|---|---|---|---|---|
| N/A | Ramp Length LT (in) | 110 | N/A | Ramp Length RT (in) | 80 |
| Yes | Ramp Width LT (in) | 85 | Yes | Ramp Width RT (in) | 85 |
| Yes | Ramp Run Slope LT (%) | 5.1 | Yes | Ramp Run Slope RT (%) | 0.8 |
| Yes | Landing Cross Slope (%) | 3.5 | | DWS Offset Type | Single |
