# Access Compliance Report Public Rights-of-Way (Curb Ramps)

Main Street: GATEWAY\_DR Cross Street: ORANGE\_KNOLL\_DR Location: SW

ADA ID: RPRK211013171631 Ramp Type: Type 4 - Parallel Initial Pass/Fail: Fail Overall Compliance: No Severity Score: 2

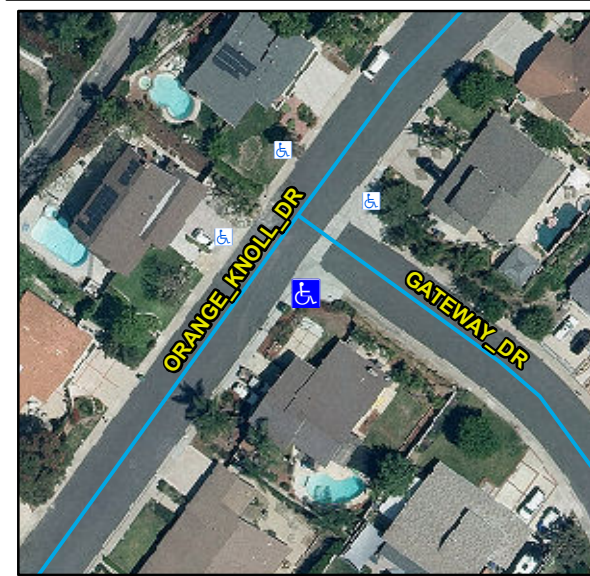
| Compliance | Description | Data | Compliance | Description | Data |
|---|---|---|---|---|---|
| No | Ramp Cross Slope LT (%) | 4.3 | Yes | Ramp Cross Slope RT (%) | 0.7 |

Possible Solutions:  
**Remove & Replace Curb Ramp With Two New Directional Ramps or Equivalent.**

OC Std/PROW:  
**R304.5.3, STD 1115**

Total Cost: \$ 4000
