# Access Compliance Report Public Rights-of-Way (Curb Ramps)

Main Street: **FOOTHILL\_BLV** Cross Street: **ORANGE\_KNOLL\_DR** Location: **S**

ADA ID: **RPRK211013172329** Ramp Type: **Type 4 - Parallel** Initial Pass/Fail: **Pass** Overall Compliance: **No** Severity Score: **5**

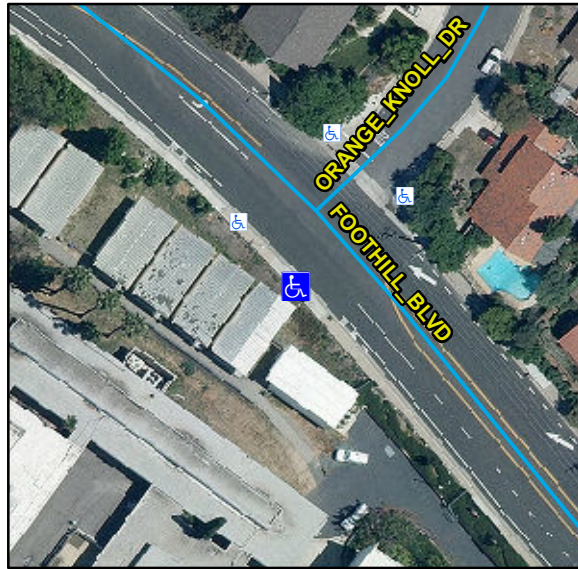
| Compliance | Description | Data | Compliance | Description | Data |
|---|---|---|---|---|---|
| <b>N/A</b> | Landing Length (in) | <b>52</b> | <b>No</b> | DWS Contrast | <b>No</b> |
| <b>No</b> | Gutter Ponding | <b>Yes</b> | <b>Yes</b> | Curb Slope | <b>4.6</b> |

**Remove & Replace Detectable Warning System.  
Gutter Ponding Observed.**

**R305.1.3, R302.7, STD 1115**

Total Cost: \$ **1052**
