# Access Compliance Report Public Rights-of-Way (Curb Ramps)

Main Street: HUNTSMAN\_RD Cross Street: SKYLINE\_DR Location: SE

ADA ID: RPRK211013181032 Ramp Type: Type 4 - Parallel Initial Pass/Fail: Fail Overall Compliance: No Severity Score: 2

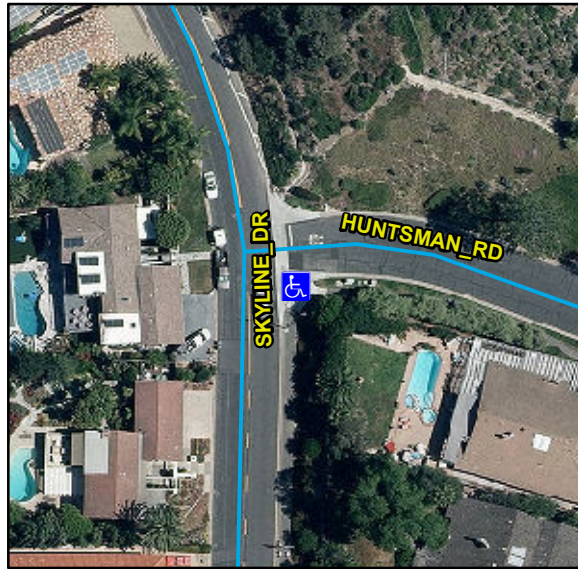
| Compliance | Description | Data | Compliance | Description | Data |
|---|---|---|---|---|---|
| Yes | Ramp Cross Slope LT (%) | 1.6 | No | Ramp Cross Slope RT (%) | 2.3 |

Remove & Replace Curb Ramp With Two New Directional Ramps or Equivalent.

R304.5.3, STD 1115
