# Access Compliance Report Public Rights-of-Way (Curb Ramps)

| Main Street: LEMON_HEIGHTS_DR | | Cross Street: SKYLINE_DR | | Location: | E |
| ADA ID: RPRK211014105609 | Ramp Type: Type 7 - Directional 2 | Initial Pass/Fail: Fail | Overall Compliance: No | Severity Score: | 2 |

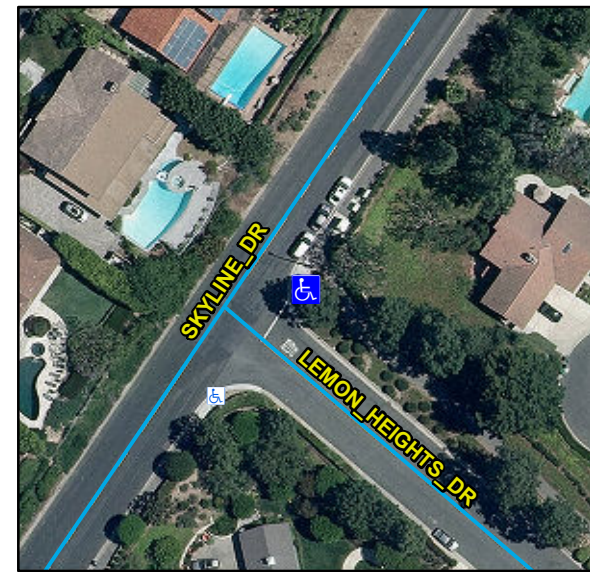
N/A

Possible Solutions:

Remove & Replace Entire Ramp.

R304.5.3, STD 1115

Total Cost: \$ 3080

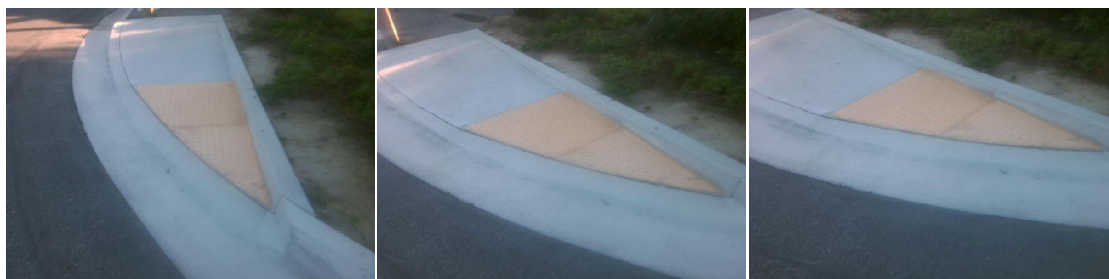
| Compliance | Description | Data | Compliance | Description | Data |
|---|---|---|---|---|---|
| Yes | Ramp Run Slope (%) | 3 | N/A | Flare Slope LT (%) | N/A |
| No | Ramp Cross Slope (%) | 2.8 | N/A | Flare Traversable LT | N/A |
| N/A | Grade Break Slope (%) | 3 | | | N/A |
| N/A | Grade Break Cross Slope (%) | 2.8 | N/A | Flare Slope RT (%) | N/A |
| Yes | Overall Surface Condition | Acceptable | Yes | Perp Joint Present | Yes |
