# Access Compliance Report Public Rights-of-Way (Curb Ramps)

Main Street: LEMON\_HEIGHTS\_DR Cross Street: SKYLINE\_DR Location: S

ADA ID: RPRK211014105922 Ramp Type: Type 7 - Directional 2 Initial Pass/Fail: Fail Overall Compliance: No Severity Score: 2

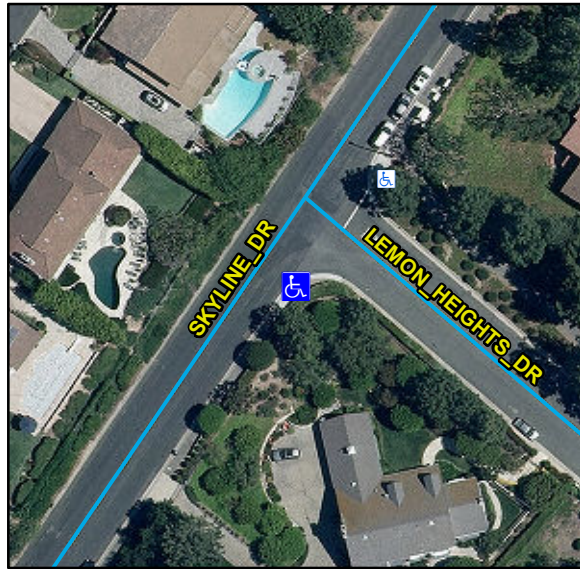
| Compliance | Description | Data | Compliance | Description | Data |
|---|---|---|---|---|---|
| No | Ramp Cross Slope (%) | 2.8 | N/A | Flare Traversable LT | N/A |

Remove & Replace Entire Ramp.

R304.5.3, STD 1115
