# Access Compliance Report Public Rights-of-Way (Curb Ramps)

Main Street: SADDLERY\_RD Cross Street: LEMON\_HEIGHTS\_DR Location: E

ADA ID: RPRK211014110353 Ramp Type: Type 6 - Directional 1 Initial Pass/Fail: Pass Overall Compliance: No Severity Score: 35

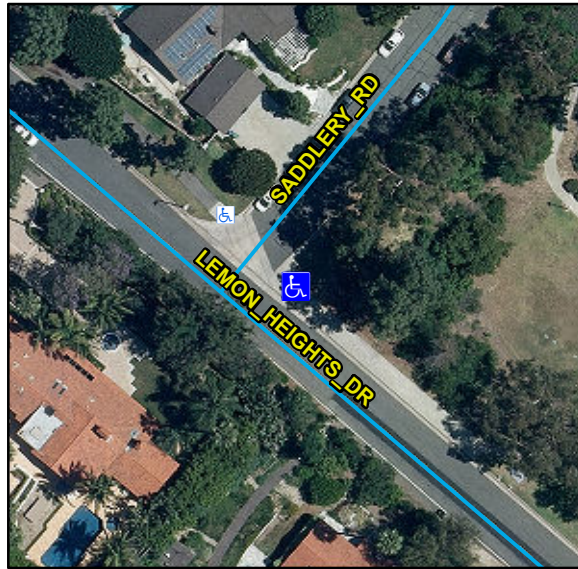
| Compliance | Description | Data | Compliance | Description | Data |
|---|---|---|---|---|---|
| No | Ramp Cross Slope (%) | 5.8 | N/A | Flare Traversable LT | N/A |
| No | Grade Break | No | N/A | Flare Type RT | |
| No | Landing Run Slope (%) | 10 | | DWS Offset Type | N/A |
| No | Gutter Run Slope (%) | 14.6 | | Road Cross Slope (%) | N/A |
| No | Gutter Cross Slope (%) | 9.8 | | Parallel Ramp Side | Left |

Remove & Replace Entire Ramp. Remove & Replace Gutter.
