# Access Compliance Report Public Rights-of-Way (Curb Ramps)

Main Street: SADDLERY\_RD Cross Street: LEMON\_HEIGHTS\_DR Location: NE

ADA ID: RPRK211014111334 Ramp Type: Type 6 - Directional 1 Initial Pass/Fail: Fail Overall Compliance: No Severity Score: 30

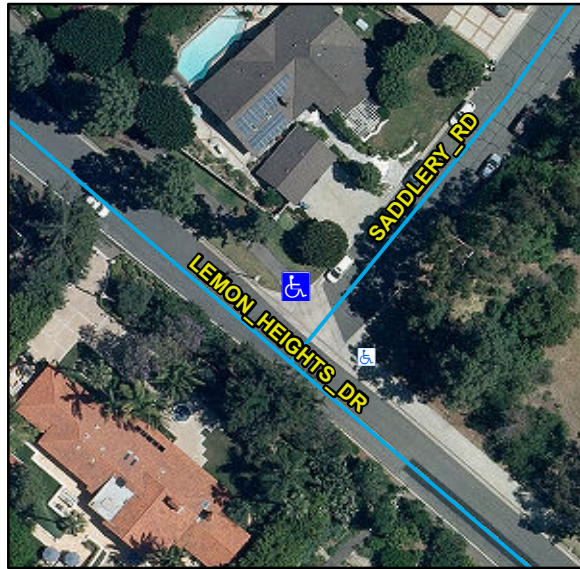
| Compliance | Description | Data | Compliance | Description | Data |
|---|---|---|---|---|---|
| No | Ramp Run Slope (%) | 17.2 | N/A | Flare Slope LT (%) | N/A |

Remove & Replace Entire Ramp.
