# Access Compliance Report Public Rights-of-Way (Curb Ramps)

Main Street: LOWER\_LAKE\_DR Cross Street: LAKE\_COURT\_DR Location: NE

ADA ID: RPRK211014112739 Ramp Type: Type 1 - Perpendicular Diagonal Initial Pass/Fail: Fail Overall Compliance: No Severity Score: 15

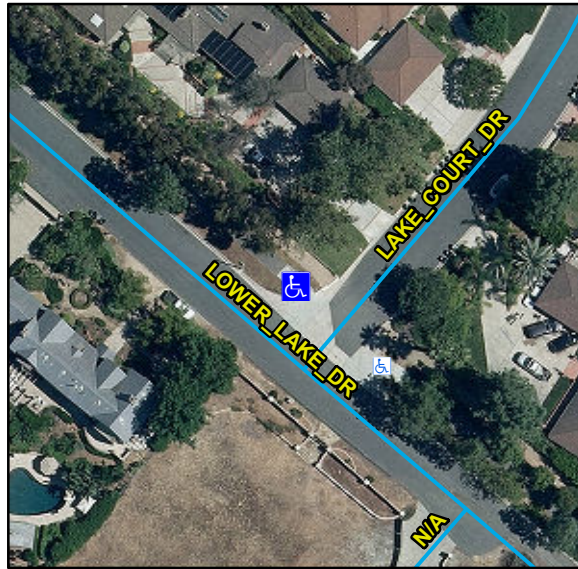
| Compliance | Description | Data | Compliance | Description | Data |
|---|---|---|---|---|---|
| No | Ramp Run Slope (%) | 9.9 | N/A | Flare Slope LT (%) | N/A |

Remove & Replace Curb Ramp With Two New Directional Ramps or Equivalent.

R304.2.2, STD 1115
