# Access Compliance Report Public Rights-of-Way (Curb Ramps)

Main Street: LOWER\_LAKE\_DR Cross Street: BENT\_TREE\_RD Location: NE

ADA ID: RPRK211014113353 Ramp Type: Type 1 - Perpendicular Diagonal Initial Pass/Fail: Fail Overall Compliance: No Severity Score: 15

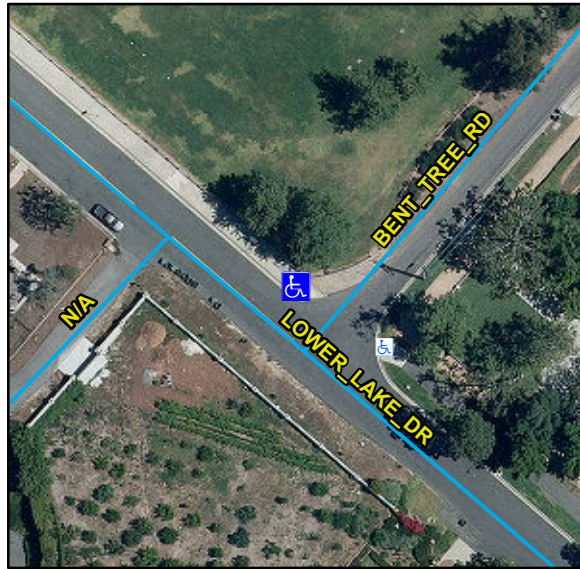
R304.2.2, R304.5.3, STD 1115

| Compliance | Description | Data | Compliance | Description | Data |
|---|---|---|---|---|---|
| No | Ramp Cross Slope (%) | 5.1 | N/A | Flare Traversable LT | N/A |

Remove & Replace Curb Ramp With Two New Directional Ramps or Equivalent.
