# Access Compliance Report Public Rights-of-Way (Curb Ramps)

Main Street: OMEGA\_DR Cross Street: BROWNING\_AVE Location: SW

ADA ID: RPRK211014115454 Ramp Type: Type 7 - Directional 2 Initial Pass/Fail: Fail Overall Compliance: No Severity Score: 2

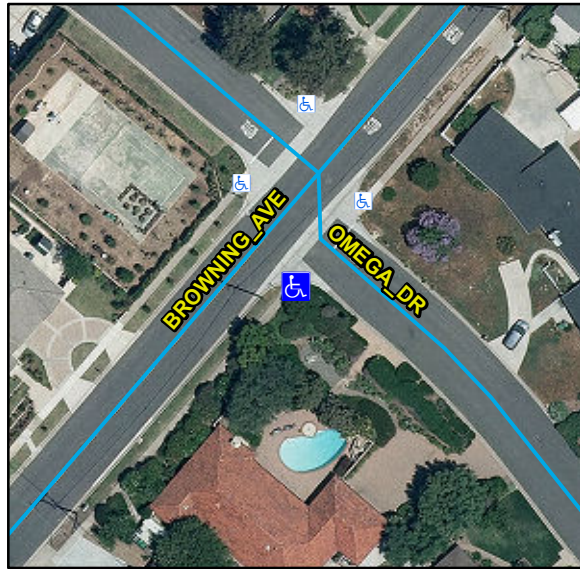
| Compliance | Description | Data | Compliance | Description | Data |
|---|---|---|---|---|---|
| No | Ramp Cross Slope (%) | 2.3 | N/A | Flare Traversable LT | N/A |

Possible Solutions:

Remove & Replace Entire Ramp.

R304.5.3, STD 1115
