# Access Compliance Report Public Rights-of-Way (Curb Ramps)

| Main Street: OMEGA_DR | | Cross Street: BROWNING_AVE | | Location: | E |
| ADA ID: RPRK211014115635 | Ramp Type: Type 7 - Directional 2 | Initial Pass/Fail: Fail | Overall Compliance: No | Severity Score: | 2 |

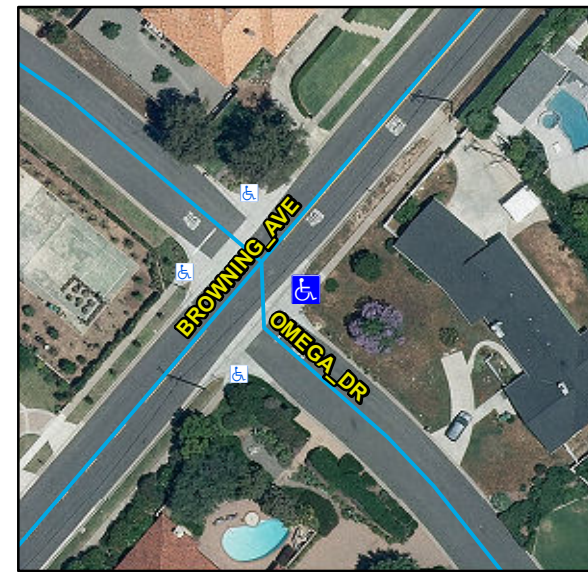
| Compliance | Description | Data | Compliance | Description | Data |
|---|---|---|---|---|---|
| No | Ramp Cross Slope (%) | 2.8 | N/A | Flare Traversable LT | N/A |

Possible Solutions:

**Remove & Replace Entire Ramp.**

**R304.5.3, STD 1115**

Total Cost: \$ 3080
