# Access Compliance Report Public Rights-of-Way (Curb Ramps)

Main Street: OMEGA\_DR Cross Street: BROWNING\_AVE Location: W

ADA ID: RPRK211014115807 Ramp Type: Type 7 - Directional 2 Initial Pass/Fail: Fail Overall Compliance: No Severity Score: 2

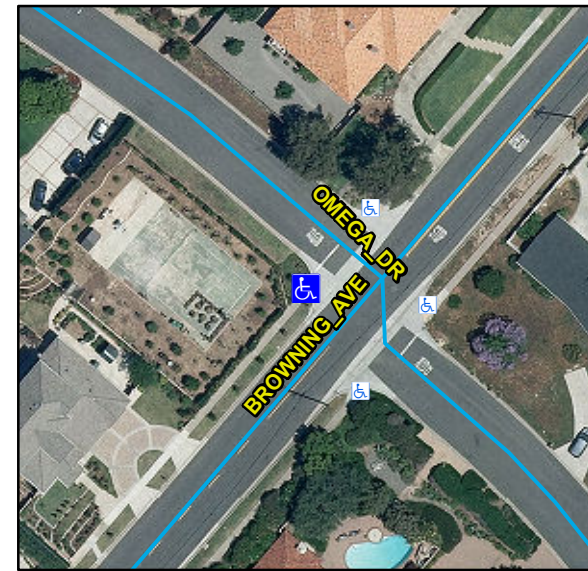
| Compliance | Description | Data | Compliance | Description | Data |
|---|---|---|---|---|---|
| No | Ramp Cross Slope (%) | 3.1 | N/A | Flare Traversable LT | N/A |

Remove & Replace Entire Ramp.
