# Access Compliance Report Public Rights-of-Way (Curb Ramps)

Main Street: FAIR\_WEATHER\_RD Cross Street: BROWNING\_AVE Location: N

ADA ID: RPRK211014125123 Ramp Type: Type 1 - Perpendicular Diagonal Initial Pass/Fail: Pass Overall Compliance: No Severity Score: 6

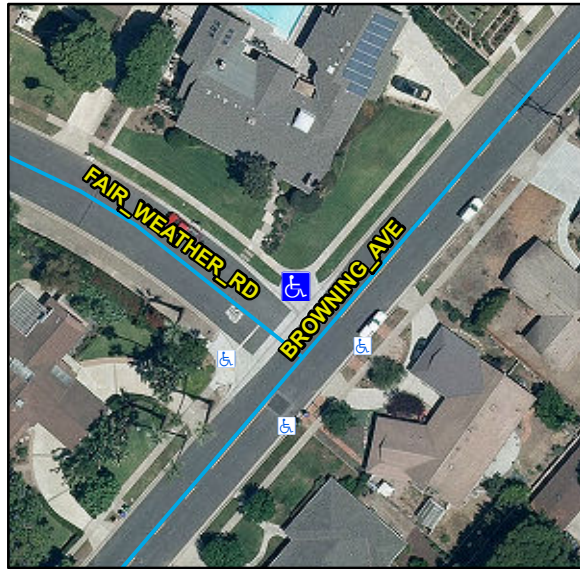
| Compliance | Description | Data | Compliance | Description | Data |
|---|---|---|---|---|---|
| No | Landing Run Slope (%) | 3.1 | N/A | Flare Traversable RT | Yes |
| Yes | Gutter Ponding | No | No | Curb Slope | 11.7 |
| No | Gutter Run Slope (%) | 5.7 | | Road Cross Slope (%) | 9.1 |

Remove & Replace Curb Ramp With Two New Directional Ramps or Equivalent. Remove & Replace Gutter.

R304.2.2, R304.2.1, R304.2.2-Perp, R304.3.2-Para, R304.5.4, STD 1115
