# Access Compliance Report Public Rights-of-Way (Curb Ramps)

Main Street: BROWNING\_AVE Cross Street: FAIR\_WEATHER\_RD Location: W

ADA ID: RPRK211014125401 Ramp Type: Type 1 - Perpendicular Diagonal Initial Pass/Fail: Fail Overall Compliance: No Severity Score: 30

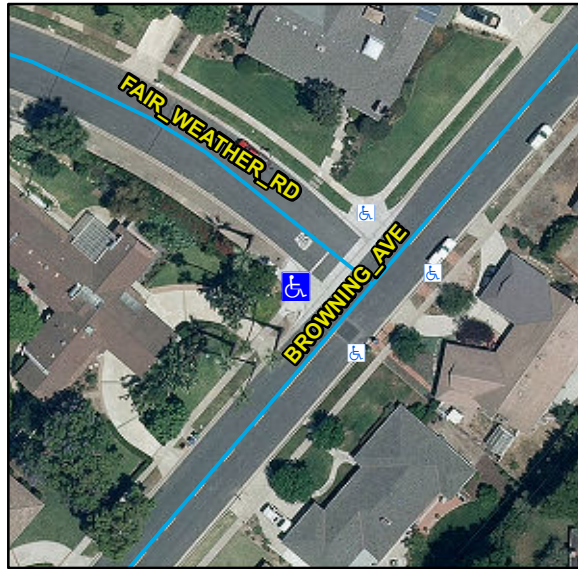
| Compliance | Description | Data | Compliance | Description | Data |
|---|---|---|---|---|---|
| No | Ramp Cross Slope (%) | 8.3 | N/A | Flare Traversable LT | N/A |
| N/A | Gutter Ponding | N/A | No | Curb Slope | 14.9 |

Remove & Replace Curb Ramp With Two New Directional Ramps or Equivalent.

R304.2.2, R304.5.3, STD 1115
