# Access Compliance Report Public Rights-of-Way (Curb Ramps)

Main Street: FAIR\_WEATHER\_RD Cross Street: SINGING\_WOOD\_DR Location: S

ADA ID: RPRK211014125753 Ramp Type: Type 1 - Perpendicular Diagonal Initial Pass/Fail: Pass Overall Compliance: No Severity Score: 2

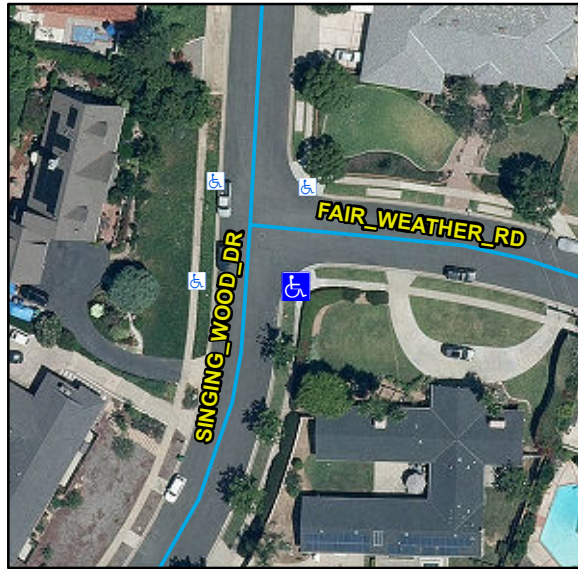
| Compliance | Description | Data | Compliance | Description | Data |
|---|---|---|---|---|---|
| N/A | Landing Movement Obstructed? | Yes | Yes | DWS Contrast | Yes |
| | Landing Movement Type | Bushes | Yes | DWS Length (in) | 36 |
| Yes | Gutter Ponding | No | No | Curb Slope | 11.8 |

Remove & Replace Curb Ramp With Two New Directional Ramps or Equivalent.

R304.2.2, R304.2.1, STD 1115

Total Cost: \$ 6160
