# Access Compliance Report Public Rights-of-Way (Curb Ramps)

Main Street: SINGING\_WOOD\_DR Cross Street: FAIR\_WEATHER\_RD Location: E

ADA ID: RPRK211014130124 Ramp Type: Type 1 - Perpendicular Diagonal Initial Pass/Fail: Fail Overall Compliance: No Severity Score: 2

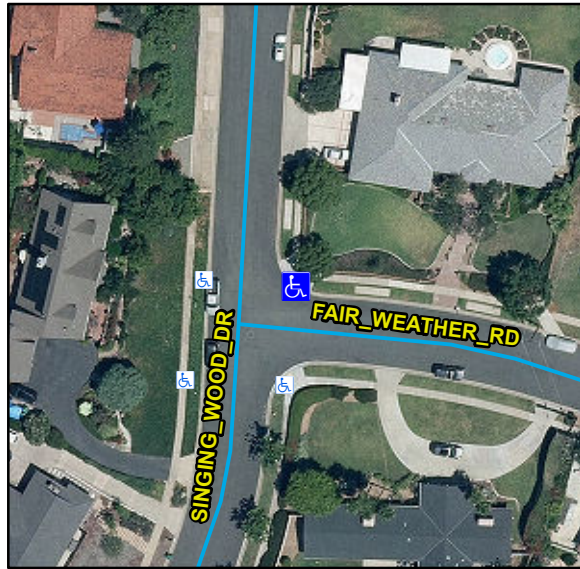
| Compliance | Description | Data | Compliance | Description | Data |
|---|---|---|---|---|---|
| No | Ramp Cross Slope (%) | 3.1 | N/A | Flare Traversable LT | N/A |

Remove & Replace Curb Ramp With Two New Directional Ramps or Equivalent.
