# Access Compliance Report Public Rights-of-Way (Curb Ramps)

Main Street: BROWNING\_AVE Cross Street: REDBERRY\_RD Location: E

ADA ID: RPRK211014130926 Ramp Type: Type 1 - Perpendicular Diagonal Initial Pass/Fail: Pass Overall Compliance: No Severity Score: 4

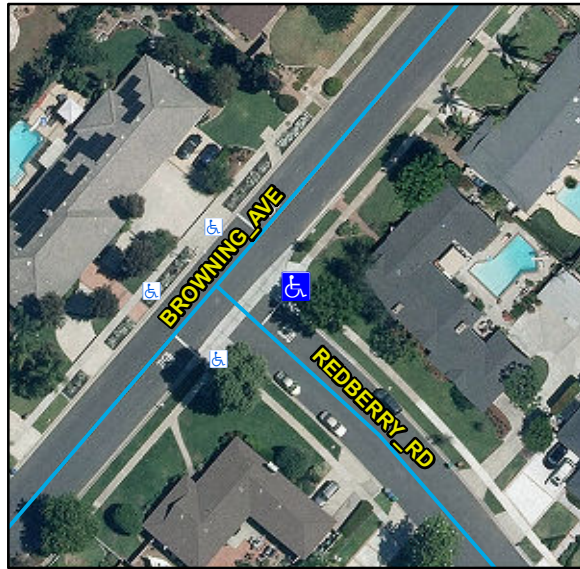
| Compliance | Description | Data | Compliance | Description | Data |
|---|---|---|---|---|---|
| Yes | Gutter Ponding | No | No | Curb Slope | 12.4 |

Remove & Replace Curb Ramp With Two New Directional Ramps or Equivalent.

R304.2.2, R304.2.1, STD 1115
