# Access Compliance Report Public Rights-of-Way (Curb Ramps)

| Main Street: REDBERRY_RD | | Cross Street: BROWNING_AVE | | Location: | S |
| ADA ID: RPRK211014131157 | Ramp Type:Type 1 - Perpendicular Diagonal Initial Pass/Fail: Fail | | Overall Compliance: No | Severity Score: | 2 |

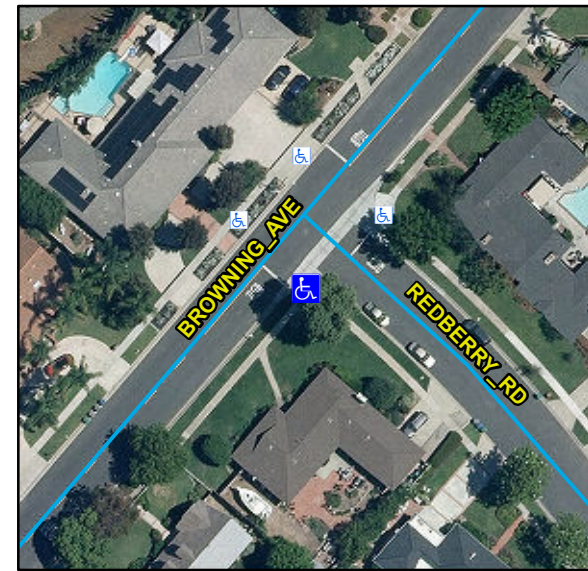
| Compliance | Description | Data | Compliance | Description | Data |
|---|---|---|---|---|---|
| No | Ramp Cross Slope (%) | 3.3 | N/A | Flare Traversable LT | N/A |

**Remove & Replace Curb Ramp With Two New Directional Ramps or Equivalent.**

**R304.2.2, R304.5.3, STD 1115**
