# Access Compliance Report Public Rights-of-Way (Curb Ramps)

Main Street: MCLEAN\_DR Cross Street: BROWNING\_AVE Location: N

ADA ID: RPRK211014132004 Ramp Type: Type 1 - Perpendicular Diagonal Initial Pass/Fail: Pass Overall Compliance: No Severity Score: 4

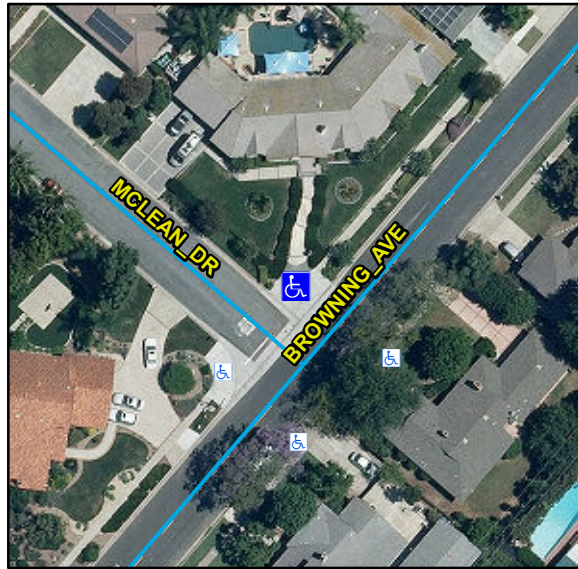
| Compliance | Description | Data | Compliance | Description | Data |
|---|---|---|---|---|---|
| Yes | Gutter Ponding | No | No | Curb Slope | 14.9 |
| No | Gutter Cross Slope (%) | 2.1 | | | |

Remove & Replace Curb Ramp With Two New Directional Ramps or Equivalent. Remove & Replace Gutter.
