# Access Compliance Report Public Rights-of-Way (Curb Ramps)

| Main Street: BROWNING_AVE | | Cross Street: MCLEAN_DR | | Location: | W |
| ADA ID: RPRK211014132307 | Ramp Type:Type 1 - Perpendicular Diagonal Initial Pass/Fail: Fail | | Overall Compliance: No | Severity Score: | 2 |

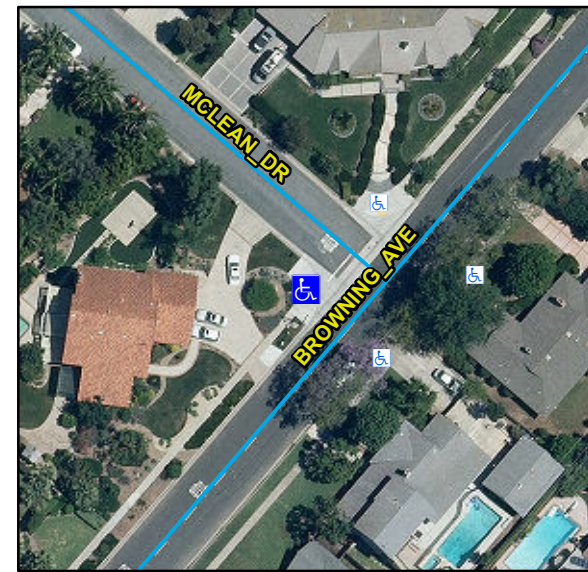
| Compliance | Description | Data | Compliance | Description | Data |
|---|---|---|---|---|---|
| No | Ramp Cross Slope (%) | 2.7 | N/A | Flare Traversable LT | N/A |

Possible Solutions:

**Remove & Replace Curb Ramp With Two New Directional Ramps or Equivalent.**

**R304.2.2, R204.3, R304.5.3, STD 1115**

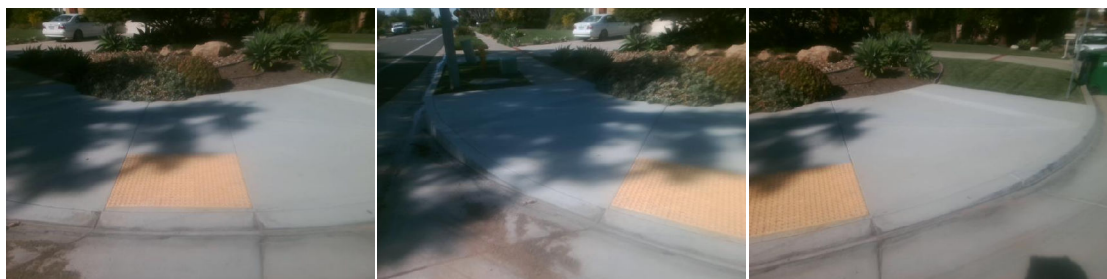
| Compliance | Description | Data | Compliance | Description | Data |
|---|---|---|---|---|---|
| N/A | Ramp Length (in) | 134 | N/A | Flare Type LT | |
| Yes | Ramp Width (in) | 48 | | | N/A |
| Yes | Ramp Run Slope (%) | 6.7 | N/A | Flare Slope LT (%) | N/A |
