# Access Compliance Report Public Rights-of-Way (Curb Ramps)

| Main Street: RANCHWOOD_RD | | Cross Street: LA_COLINA_DR | | Location: | NW |
| ADA ID: RPRK211014132914 | Ramp Type: Type 1 - Perpendicular Diagonal Initial Pass/Fail: Fail | | Overall Compliance: No | Severity Score: | 2 |

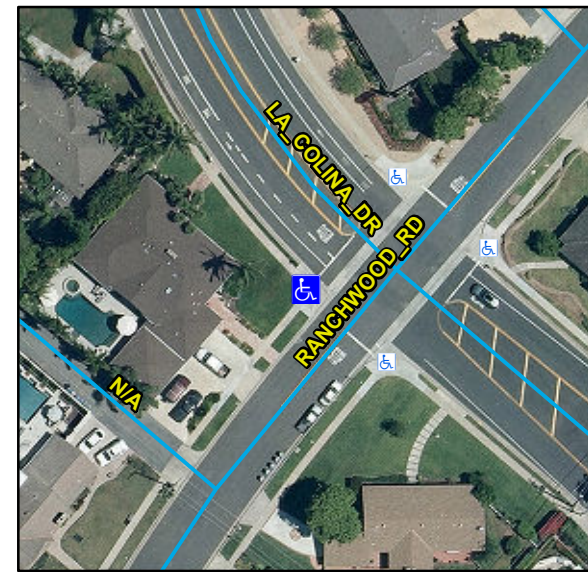
| Compliance | Description | Data | Compliance | Description | Data |
|---|---|---|---|---|---|
| No | Ramp Cross Slope (%) | 3 | N/A | Flare Traversable LT | N/A |

**Remove & Replace Curb Ramp With Two New Directional Ramps or Equivalent.**

**R304.2.2, R304.5.3, STD 1115**

Total Cost: \$ 6160

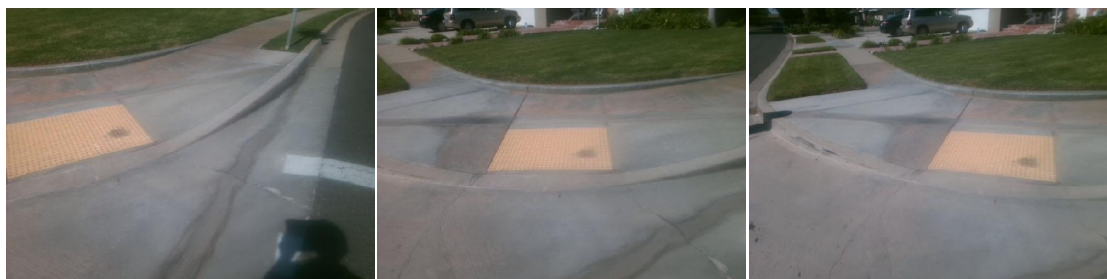
| Compliance | Description | Data | Compliance | Description | Data |
|---|---|---|---|---|---|
| Yes | Overall Surface Condition: Acceptable | | Yes | Perp Joint Present | Yes |
| | Cross Gutter Present? | Yes | | Spandrel Present? | Yes |
