# Access Compliance Report Public Rights-of-Way (Curb Ramps)

Main Street: LA\_COLINA\_DR Cross Street: RANCHWOOD\_RD Location: S

ADA ID: RPRK211014133053 Ramp Type: Type 1 - Perpendicular Diagonal Initial Pass/Fail: Fail Overall Compliance: No Severity Score: 2

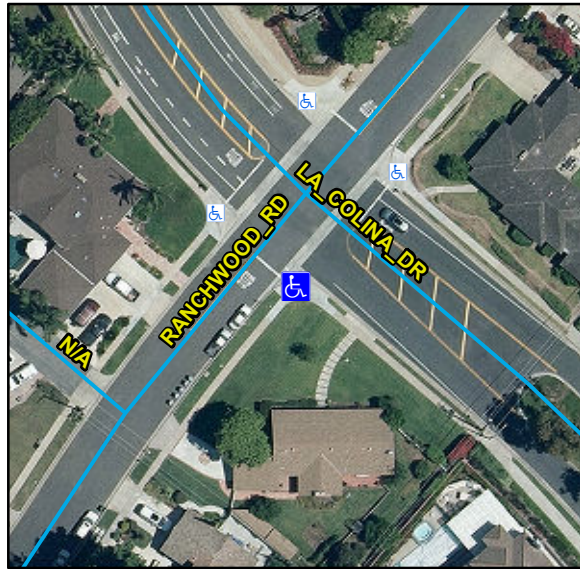
R304.2.2, R304.5.3, STD 1115

| Compliance | Description | Data | Compliance | Description | Data |
|---|---|---|---|---|---|
| No | Ramp Cross Slope (%) | 2.4 | N/A | Flare Traversable LT | N/A |

Remove & Replace Curb Ramp With Two New Directional Ramps or Equivalent.
