# Access Compliance Report Public Rights-of-Way (Curb Ramps)

| Main Street: RANCHWOOD_RD | | Cross Street: LA_COLINA_DR | | Location: | SE |
| ADA ID: RPRK211014133258 | Ramp Type: Type 1 - Perpendicular Diagonal Initial Pass/Fail: Fail | | Overall Compliance: No | Severity Score: | 15 |

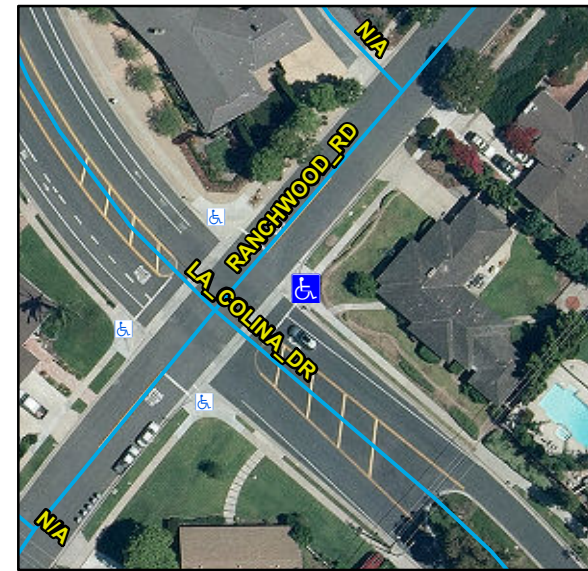
| Compliance | Description | Data | Compliance | Description | Data |
|---|---|---|---|---|---|
| No | Ramp Run Slope (%) | 8.4 | N/A | Flare Slope LT (%) | N/A |
| | Crossing 1 Slope (%) | 8.3 | | Crossing 2 Slope (%) | 12 |

**Remove & Replace Curb Ramp With Two New Directional Ramps or Equivalent.**

**R304.2.2, STD 1115**

Total Cost: \$ 6160
