# Access Compliance Report Public Rights-of-Way (Curb Ramps)

Main Street: LA\_COLINA\_DR Cross Street: BROWNING\_AVE Location: SW

ADA ID: RPRK211014134314 Ramp Type: Type 4 - Parallel Initial Pass/Fail: Pass Overall Compliance: No Severity Score: 0

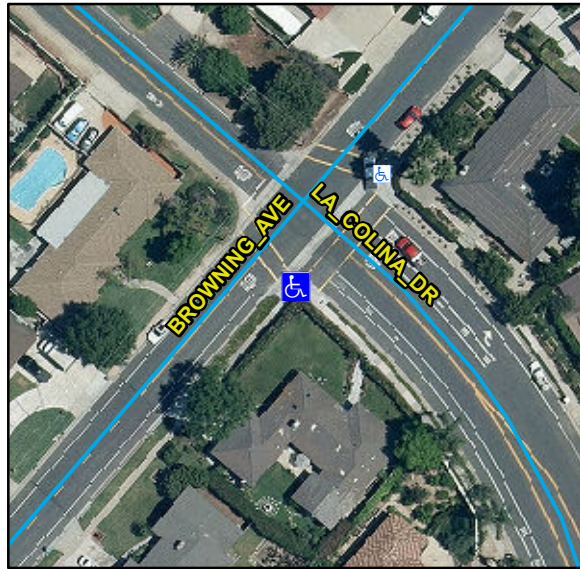
| Compliance | Description | Data | Compliance | Description | Data |
|---|---|---|---|---|---|
| No | Landing Cross Slope (%) | 2.4 | | DWS Offset Type | Single |
| Yes | Gutter Ponding | No | No | Curb Slope | 9.6 |
| No | Gutter Cross Slope (%) | 2.4 | Yes | Perpendicular Joint Present | Yes |

Remove & Replace Curb Ramp With Two New Directional Ramps or Equivalent. Remove & Replace Gutter.

R304.2.2, R304.5.3, STD 1115
