# Access Compliance Report Public Rights-of-Way (Curb Ramps)

Main Street: LA\_BELLA\_DR Cross Street: LA\_COLINA\_DR Location: SE

ADA ID: RPRK211014135220 Ramp Type: Type 1 - Perpendicular Diagonal Initial Pass/Fail: Fail Overall Compliance: No Severity Score: 15

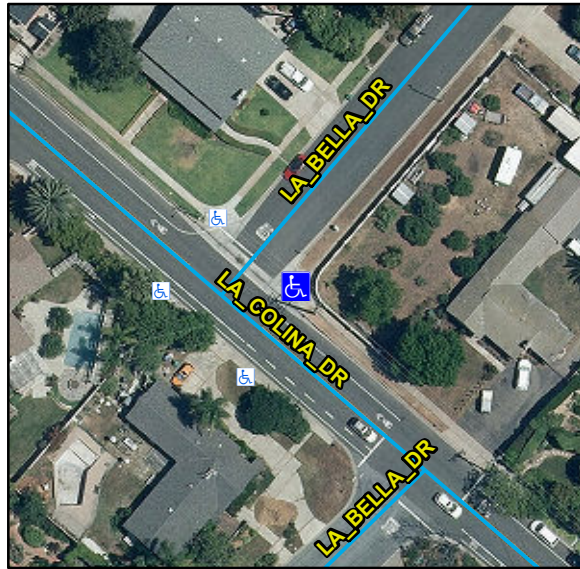
| Compliance | Description | Data | Compliance | Description | Data |
|---|---|---|---|---|---|
| No | Ramp Run Slope (%) | 9 | N/A | Flare Slope LT (%) | N/A |

Remove & Replace Curb Ramp With Two New Directional Ramps or Equivalent.

R304.2.2, R204.3, STD 1115
