# Access Compliance Report Public Rights-of-Way (Curb Ramps)

| Main Street: LA_COLINA_DR | | Cross Street: LA_BELLA_DR | | Location: | N |
| ADA ID: RPRK211014135917 | Ramp Type:Type 1 - Perpendicular Diagonal Initial Pass/Fail: Fail | | Overall Compliance: No | Severity Score: | 15 |

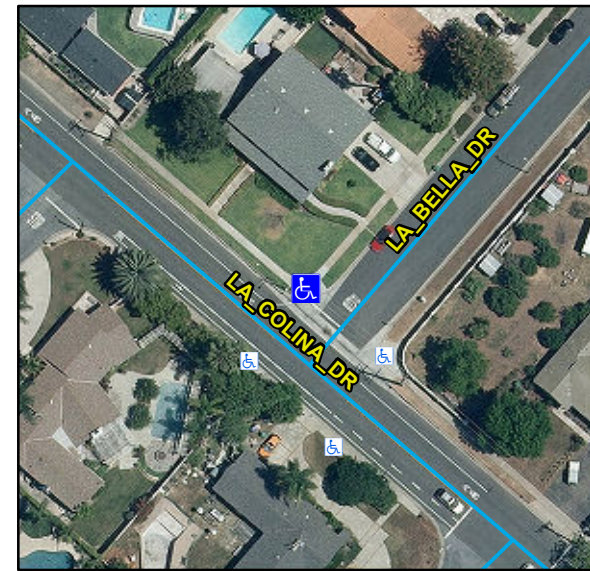
| Compliance | Description | Data | Compliance | Description | Data |
|---|---|---|---|---|---|
| No | Ramp Run Slope (%) | 8.4 | N/A | Flare Slope LT (%) | N/A |

**Remove & Replace Curb Ramp With Two New Directional Ramps or Equivalent.**

**R304.2.2, STD 1115**
