# Access Compliance Report Public Rights-of-Way (Curb Ramps)

Main Street: GARLAND\_AVE Cross Street: RED\_HILL\_AVE Location: S

ADA ID: RPRK211014143243 Ramp Type: Type 4 - Parallel Initial Pass/Fail: Fail Overall Compliance: No Severity Score: 2

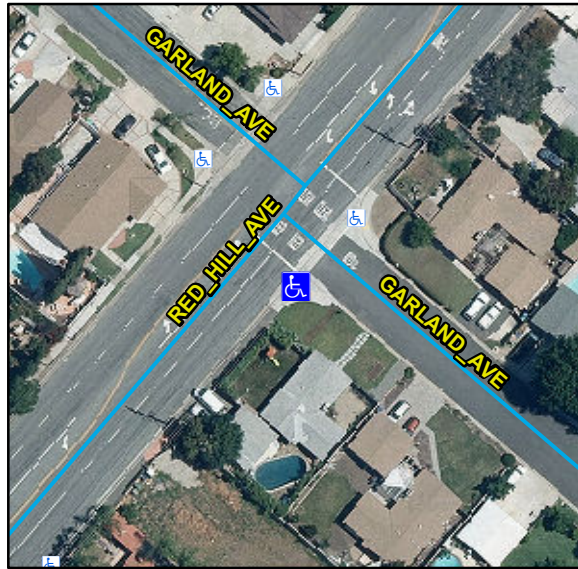
| Compliance | Description | Data | Compliance | Description | Data |
|---|---|---|---|---|---|
| No | Ramp Cross Slope LT (%) | 2.6 | No | Ramp Cross Slope RT (%) | 2.1 |

**Remove & Replace Curb Ramp With Two New Directional Ramps or Equivalent.**

**R304.5.3, STD 1115**
