# Access Compliance Report Public Rights-of-Way (Curb Ramps)

Main Street: RED\_HILL\_AVE Cross Street: GARLAND\_AVE Location: E

ADA ID: RPRK211014143523 Ramp Type: Type 4 - Parallel Initial Pass/Fail: Fail Overall Compliance: No Severity Score: 16

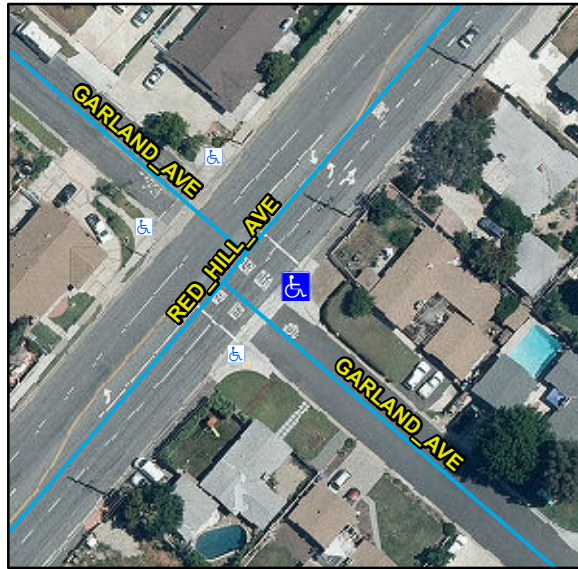
| Compliance | Description | Data | Compliance | Description | Data |
|---|---|---|---|---|---|
| Yes | Ramp Run Slope LT (%) | 7.3 | No | Ramp Run Slope RT (%) | 8.6 |
| Yes | Ramp Cross Slope LT (%) | 0.1 | No | Ramp Cross Slope RT (%) | 2.2 |

Remove & Replace Curb Ramp With Two New Directional Ramps or Equivalent.

R304.3.2, R304.5.3, STD 1115
