# Access Compliance Report Public Rights-of-Way (Curb Ramps)

Main Street: DEL\_REY\_DR Cross Street: IRVINE\_BLV Location: SE

ADA ID: RPRK211014144117 Ramp Type: Type 4 - Parallel Initial Pass/Fail: Fail Overall Compliance: No Severity Score: 2

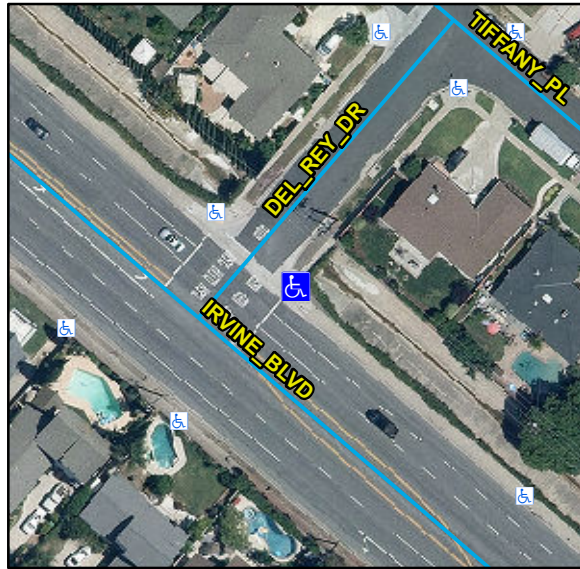
| Compliance | Description | Data | Compliance | Description | Data |
|---|---|---|---|---|---|
| No | Ramp Cross Slope LT (%) | 2.2 | Yes | Ramp Cross Slope RT (%) | 0.8 |

Remove & Replace Curb Ramp With Two New Directional Ramps or Equivalent.

R304.5.3, STD 1115
